# Town of St. Marys Wastewater Operations Report 2016 FOURTH QUARTER

Submitted by:  
Ontario Clean Water Agency  
Date: January 1 – December 31, 2016

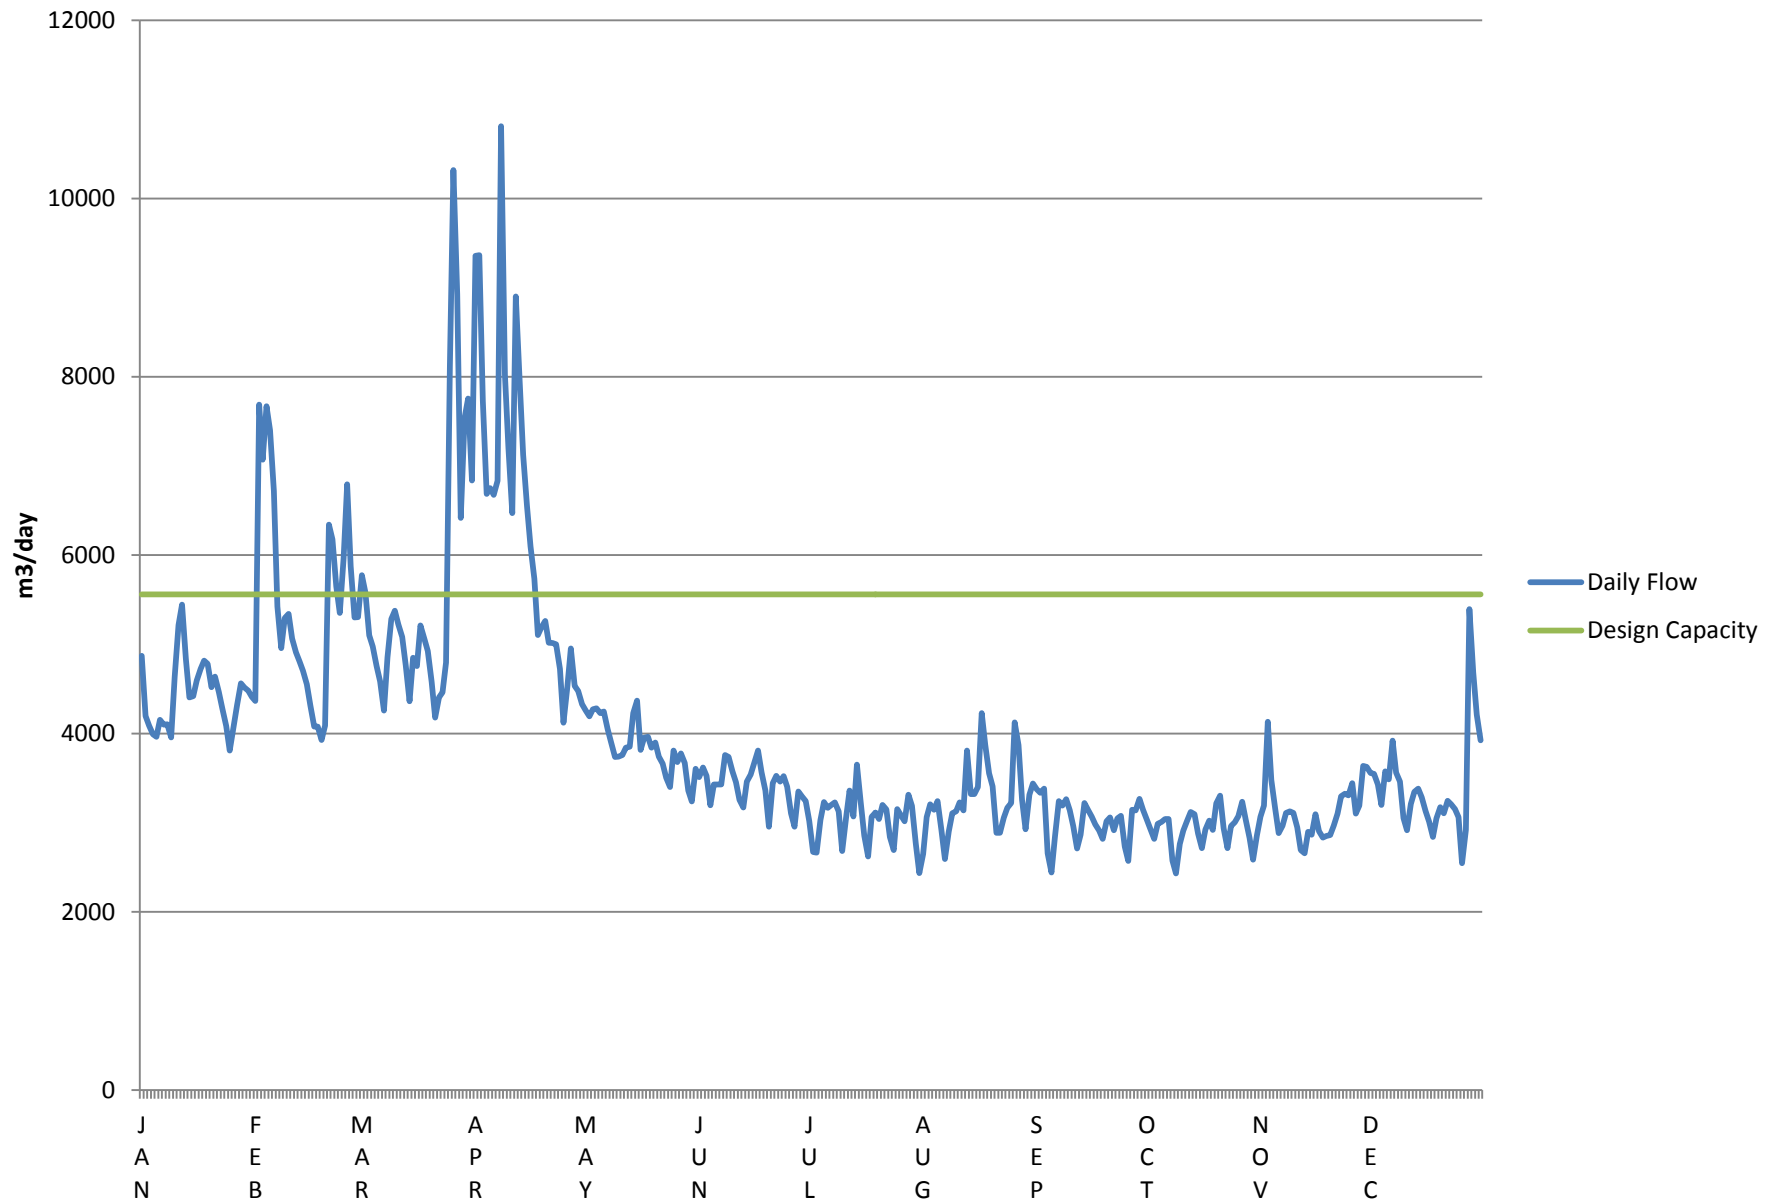
## 2016 Flows

## **FLOW REPORT**
