# **Grand Trunk Railway Station: Designation Statements**

5 James Street North, St. Marys, Ontario Lots 1 and 2, East Side, James Street North

Municipal By-Law: 33-1987

Revised by Heritage St. Marys for St. Marys Town Council December 2016

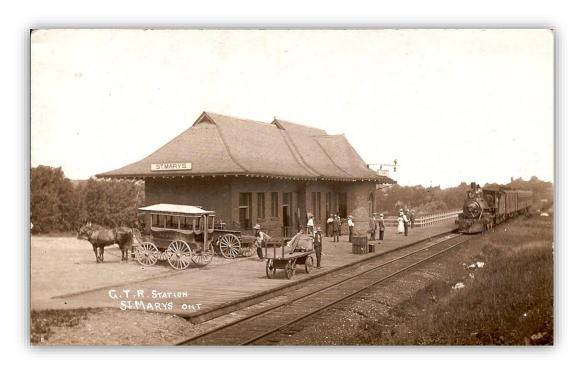
Grand Trunk Railway Station, St. Marys Postcard view, ca 1910

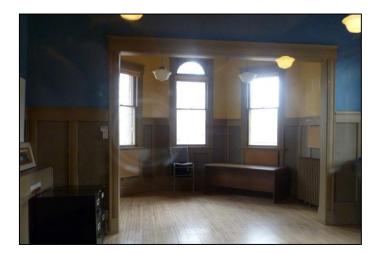
A view of the east-facing window complex showing lintel, semi-circular light above two double-hung windows with bracket between.

- The operator's bay has two, double-hung east-facing windows, set side by side, with an elongated bracket between the two components.
- The main west-facing single door is wood with five horizontal panels. There are two wood and glass side panels with a curved brick lintel and a segmented elliptical fan light over all.

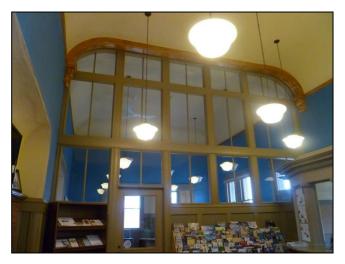
Exterior and interior view of projecting bay on north side.

- The north end of the building is a projecting bay with three windows facing northwest, north and northeast.

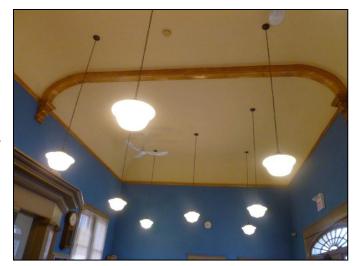
Looking up to the north to high, vaulted ceiling, showing segmented dividing wall and curved beam.

- The high central ceiling is vaulted and supported by two carved oak beams. A simple wooden crown mold bead separates the walls and ceiling.
- A wall of glass panels set in wood divides the centre area. This seems to be intended to show the separation of the general waiting area from the more private sections. This glass and wood wall extends in sections from the ceiling down to wooden panels forming the lower part of this internal wall. A door connects the space divided by this wall. This glass-paneled dividing wall was part of the 1988 restoration. No record exists of any such division being in place when the building was actively serving passengers.

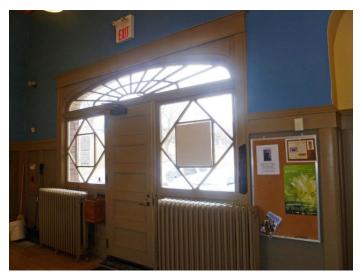
Interior view of main west-facing entrance showing elliptical fan light over five-panel door flanked by windows and panels (behind radiators); also shows wide casing, wainscoting and ledge.

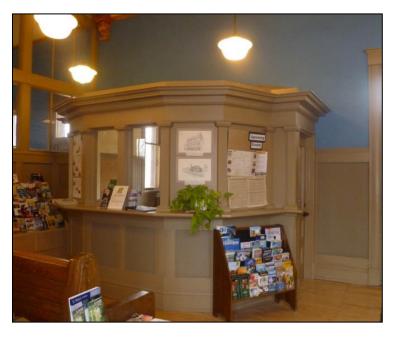
Operator's bay, projecting into the waiting area with windows and counter in place; door to office on right.

- The operator's bay protrudes into the main waiting area at its northeast corner. The trim and framing of the interior windows into this office have been restored to suggest the original, no-public-access, station operator's area. This feature has been modified to allow the interior space to be used but it is still important, showing the original functionality of the building.
